Test report

IP-Fix clip in combination with steel trapezoidal profile 35/1035

Subject determination of the wind uplift resistance

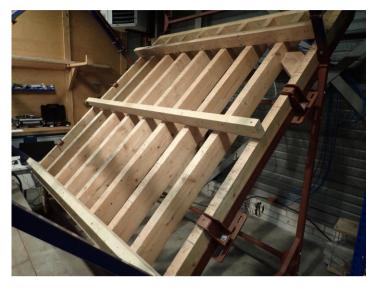
Photo 1 Overview of the substructure.

Substructure : structure of three wooden purlins, dimensions:

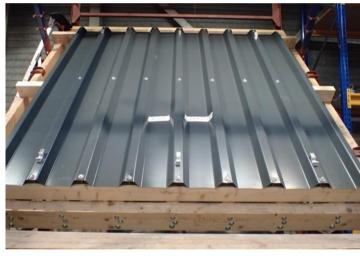
Photo 2
The trapezoidal sheets have been fixed on the purlins and six clips have been fixed to the trapezoidal sheet.

Trapezoidal profiles : on top of the purlins two steel trapezoidal profiles, type

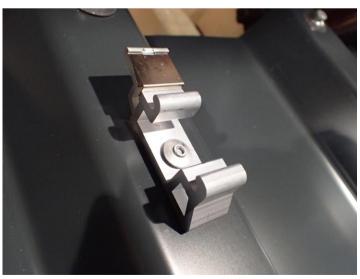
Photo 3
Detail of a IP-Fix clip fixed with a rivet.

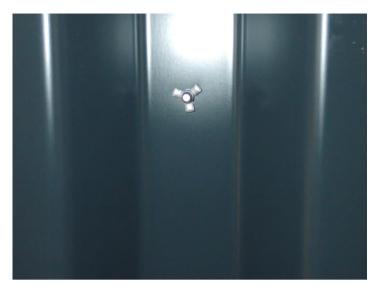
Photo 4
Detail of a rivet on the backside of the trapezoidal sheet.

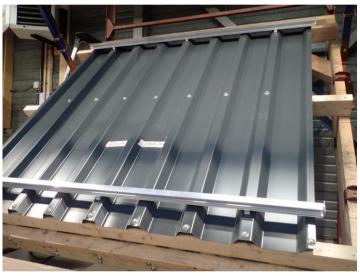
Photo 5

Two insert profiles have been fixed to the IP-Fix clips.

Mounting system : six IP-Fix clips (two rows of three clips) have been

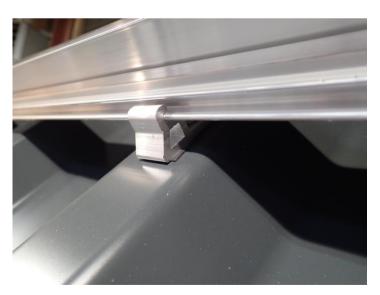
Photo 6

Detail of the fixation between the IP-Fix clip and the insert profile.

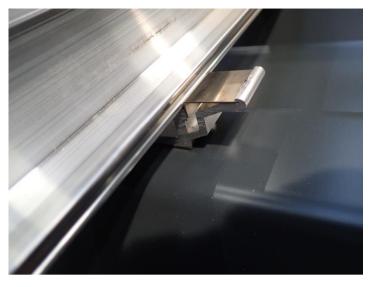
Photo 7
Detail of the fixation between the IP-Fix clip and the insert profile.

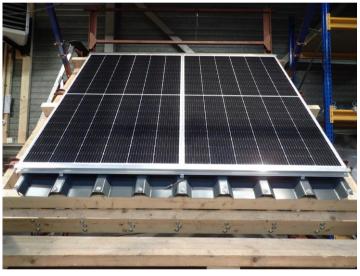
Photo 8
The PV modules have been positioned in the insert profiles.

PV modules : in between the two horizontal positioned insert profiles

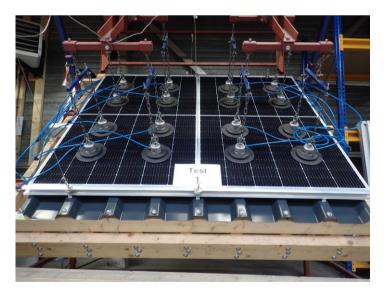
Photo 9
The suction cups are placed in position and test specimen 1 is ready for testing.

The determination of the wind uplift resistance has been performed on a system containing two PV modules in combination with two insert profiles and six IP-Fix clips on a substructure of steel trapezoidal profiles. The PV modules have been laid in portrait position. The loading of the two PV modules has been applied by using eight suction cups per PV module.

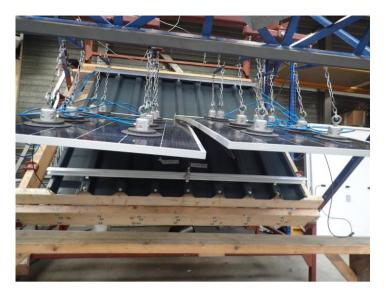
Photo 10 Detail of the failure mode of test specimen 1.

At the applied force of 8800 N the PV modules have been pulled out of the insert profile; consequently the ultimate failure has been reached.

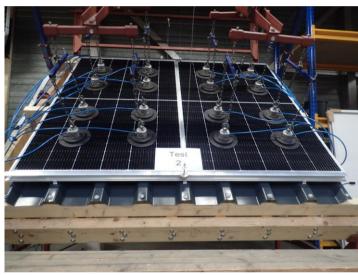
Photo 11
The suction cups are placed in position and test specimen 2 is ready for testing.

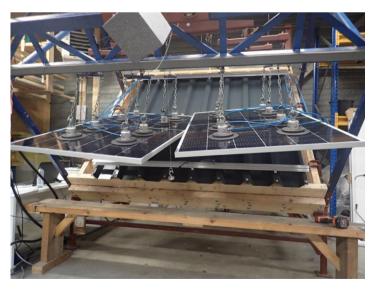
Photo 12 Detail of the failure mode of test specimen 2.

At the applied force of 7600 N the PV modules have been pulled out of the insert profile; consequently the ultimate failure has been reached.

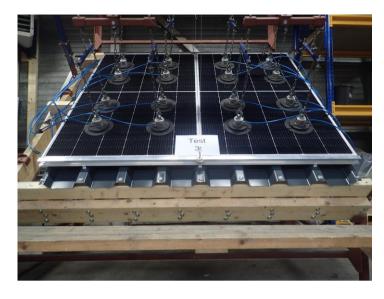
Photo 13
The suction cups are placed in position and test specimen 3 is ready for testing.

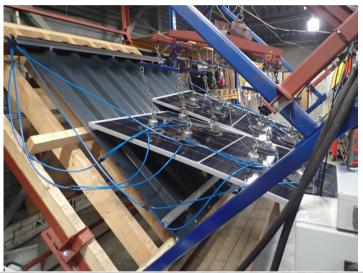
Photo 14
Detail of the failure mode of test specimen 3.

At the applied force of 8400 N the PV modules have been pulled out of the insert profile; consequently the ultimate failure has been reached.
